Killerton Park and Marshes
Green Recovery Challenge Fund
Historic Character of Watercourses
and Floodplain

Volume 1: Narrative

12th April 2021

Fjordr Ref: 16620

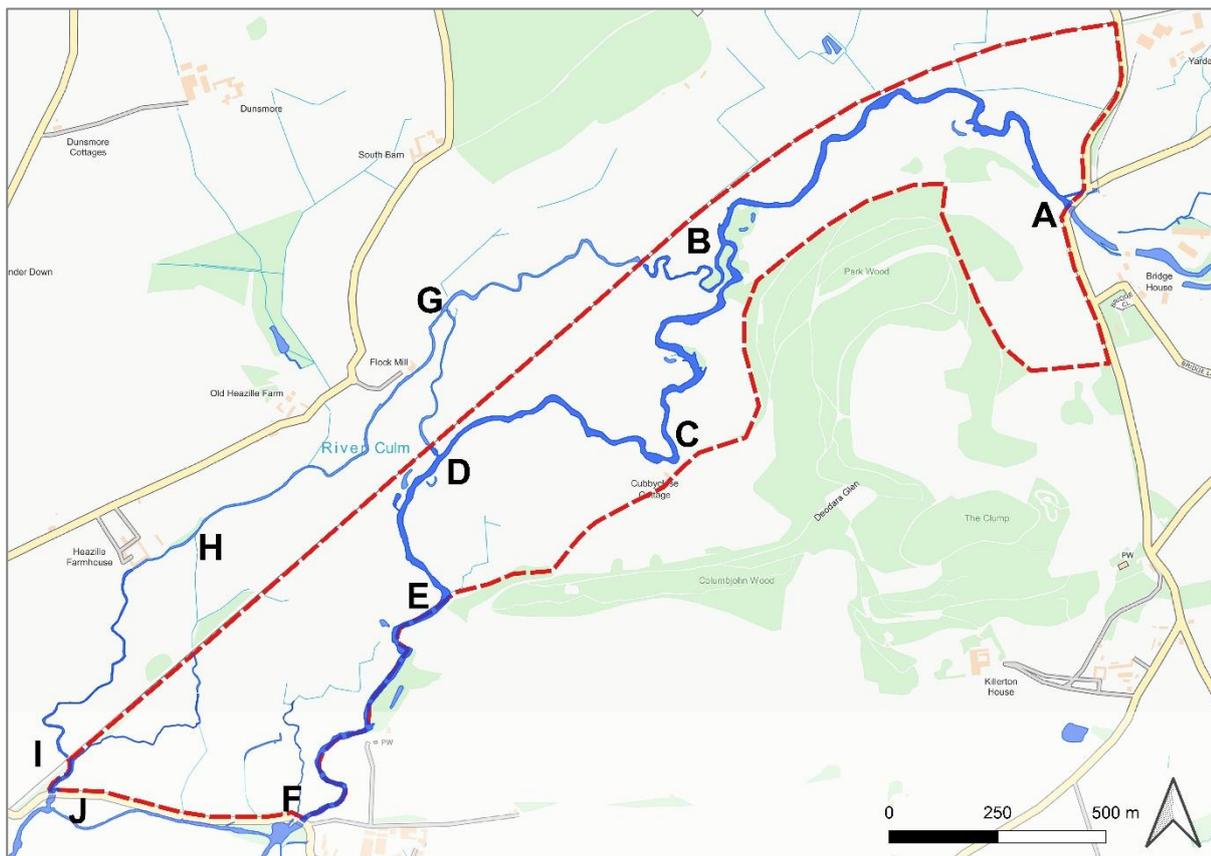
Figure 1: The route of the River Culm in the vicinity of the study area (red dashed line)

From Ellerhayes Bridge (Figure 1 - A), the Culm – in a single channel – and its floodplain sweep back to the south west, around the hill of Park Wood. Near the former site of Dolbury Cottage, the

shoulder of Killerton Hill becomes less steep and the valley broadens out. Slightly upstream, the Culm divides into two channels (B).

One channel crosses the floodplain from B towards Singleton Park (formerly Poundland), reaching the north west side of the valley just upstream of (Pound) Flock Mill, where the channel divides again (G). At this point, a weir takes water to a channel that crosses back across the valley to the south (D). The channel at Flock Mill, however, continues along the north west side of the valley to Heazille Barton (formerly Rewe Mill) before starting to cross the valley to Paddleford Bridge (J), where it leaves the study area. At a point (H) just upstream of Heazille Barton, another small channel leaves the north west channel and returns to it upstream (I) of Paddleford Bridge.

From just upstream of Dolbury Cottage (B), the main channel continues along the south east side of the valley to Cubbyclose Cottage (C) where it turns across the valley in a wide arc which is met at its apex (D) by the small channel from Flocks Mill and then returns to the south east side of the valley near the western tip of Columbjohn Wood on its distinct east-west ridge (E). The channel continues along the south east side of the valley – past the site of Columbjohn Mill, Columbjohn Chapel and the former mansion site – before leaving the study area under Columbjohn Bridge (F).

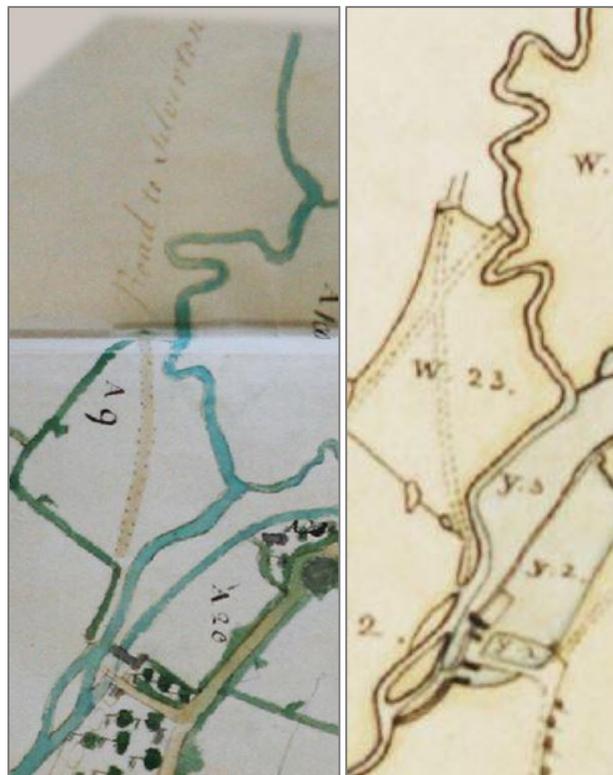
Other routes across the River Culm and its floodplain that are now extinguished might also have been important in the past. For example, the estate map from 1756 and from the early 1800s (Figure 5) indicate a 'Road to Silverton' crossing the floodplain from Columbjohn Mill across Common Marsh in the direction of Pounds Flock Mill, where Devon HER notes a hollow way (MDV108811) perhaps equivalent to that which serves Columbjohn Mill.

Figure 5: Clips of estate maps showing road / track across floodplain from Columbjohn Mill (1756 on left; early 1800s on right)

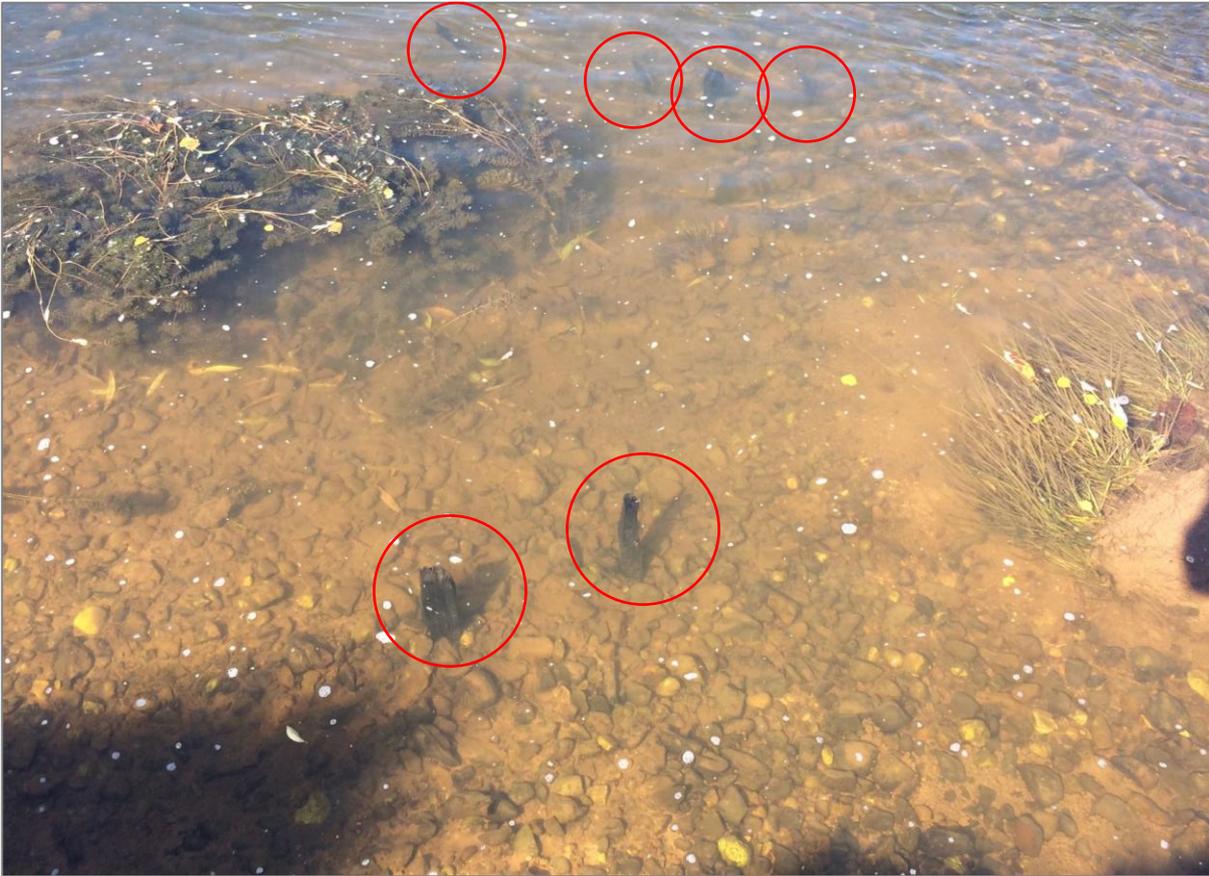
To some extent, documented uses in the recent past might provide a guide to earlier uses also. For example, when John Ackeland purchased the mansion house and manor at Columbjohn in 1580-81, it included meadows, pastures, feeding woods and under woods, leats, mills, dove houses, warrens, fishing weirs and watercourses (Balmond et al., 2020, p. 223). The reference to fish weirs is especially interesting, as this confirms a likely important use of the river that may have involved altering watercourses (Haslam, 1997, fig. 10.15) and installing timber structures that would survive very well in the waterlogged deposits of the floodplain. Indeed, timber stakes have been observed in the river close to the mansion site at Columbjohn (Figure 6). Much later, in 1786, there is a reference to making a bridge over the river for fishing, though the location is not specified (Balmond et al., 2020, p. 184). It is possible that the foot bridge noted in HWP 452 may relate to fishing, as it is not on a mapped footpath.

Figure 6: Wooden stakes (ringed) in River Culm near mansion site (Photo: Fjodr)
